**Flood Control Project Maintenance
Levee Inspections****LMA District Cover Sheet****Spring 2014 Levee Inspection Results****Reclamation District No. 0563 Tyler Island**

Spring 2014 Levee Inspection Results

Reclamation District No. 0563 Tyler Island

Waterway			Bank	Unit Miles
Unit No. 01 Georgiana Slough (Tyler Island)			Left	12.38
	Spring (March - May)	Summer (June - August)	(September - November) Fall	Winter (December - February)
Unit Maintenance Rating (Fall Only)				
Date of Inspection	03/25/2014 - 03/26/2014			
DWR Inspector	Richard Willoughby			
Accompanied By	Steve Mello RD 563

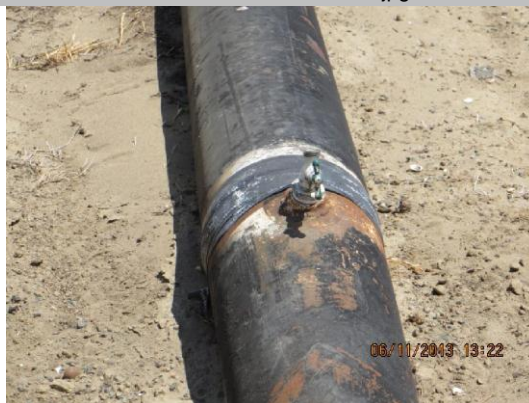
Photo 1 of 1 : UCIP_1177.jpg

Vent/filler pipe on LS slope.

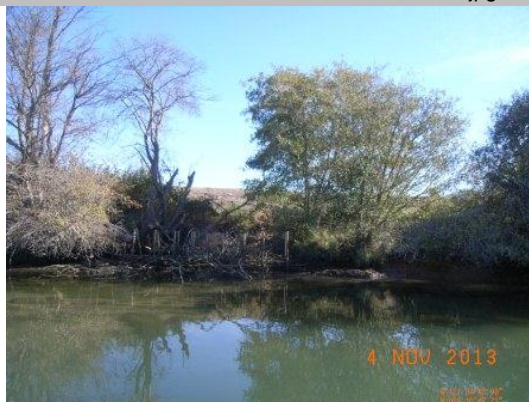
Photo 1 of 1 : USACE2013A_GEO_5-8_L_4.jpg

LM Start	6.39	Rating **	M	Issue No.	45
LM End	6.60	Issue Type +	Ma	Location *	WS
Category	Supplemental			GPS Latitude/Longitude	
				Start	End
Item	USACE Erosion Survey			38.180462 °	38.179319 °
				-121.577895 °	-121.578566 °
DWR ID

Inspector Comments: 2013: Erosion pockets into the levee prism. Erosion pockets primarily located behind unmaintained brush boxes. [2013 Site ID: GEO_5-8_L]

USACE 2013 Photo #1

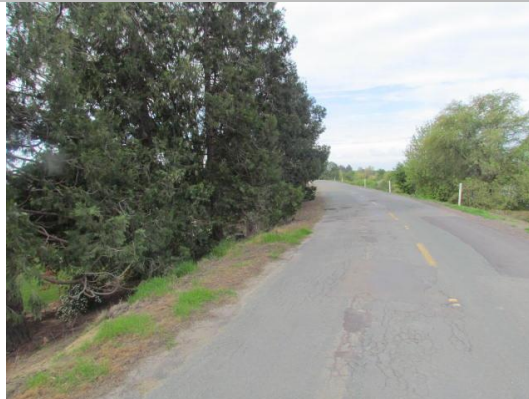
Photo 1 of 1 : richard_s_20140328_475.jpg

LM Start	6.39	Rating **	M	Issue No.	23
LM End	6.41	Issue Type +	Ma	Location *	LS
Category	Earthen Levee			GPS Latitude/Longitude	
				Start	End
Item	Trim / Thin Trees			38.181273 °	38.181165 °
				-121.575873 °	-121.576217 °
DWR ID	DWR_RD0563_01_s _ 2012_23				
Action/Comments					
Trim trees to at least five feet above ground level.

Looking south at trees on landward shoulder.

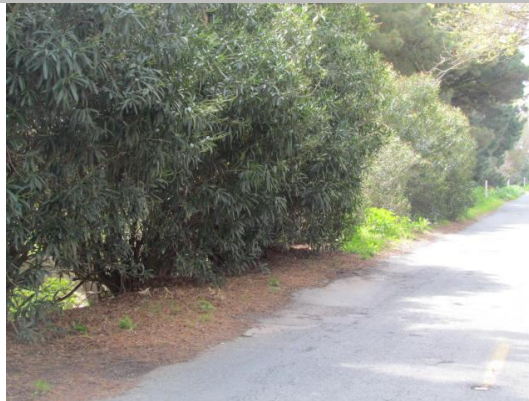
Photo 1 of 1 : richard_s_20140318_808.jpg

LM Start	6.60	Rating **	U	Issue No.	25
LM End	6.72	Issue Type +	En	Location *	LS
Category	Earthen Levee			GPS Latitude/Longitude	
				Start	End
Item	Vegetation			38.179250 °	38.177533 °
				-121.578347 °	-121.579087 °
DWR ID	DWR_RD0563_01_s _ 2012_25				
Action/Comments					
Landscaping

Looking southeast at dense landscaping on landside shoulder and slope.

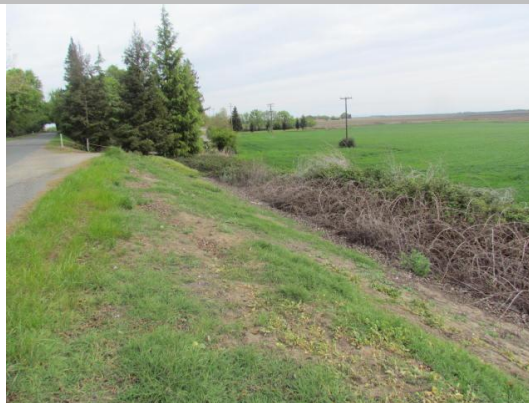
Photo 1 of 2 : richard_s_20140328_476.jpg

LM Start	6.72	Rating **	U	Issue No.	145
LM End	6.80	Issue Type +	Ma	Location *	LS
Category	Earthen Levee			GPS Latitude/Longitude	
				Start	End
Item	Vegetation				°
					°
DWR ID	DWR_RD0563_01_s_2014_145				
Action/Comments					
Remove the wild growth other than native grasses from the levee slopes.					
Inspector Comments: Dense vegetation blocking view of landward toe.

Looking north at dense dead berryvines at landward toe.

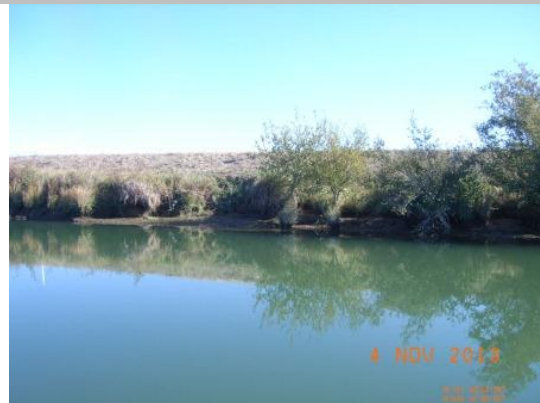
Photo 1 of 1 : USACE2013A_GEO_5-3_L_2.jpg

LM Start	6.78	Rating **	M	Issue No.	44
LM End	7.44	Issue Type +	Ma	Location *	WS
Category	Supplemental			GPS Latitude/Longitude	
				Start	End
Item	USACE Erosion Survey			38.176861 °	38.167959 °
				-121.579747 °	-121.581616 °
DWR ID					
Action/Comments					
Inspector Comments: 1997 - Pocket erosion into the toe of the levee. 2000 - Scallops in banks with small colored flags, biotech rolls present. 2001 - Staked, low fascine walls at bankline. 2003 - Still have visibly bad spots, especially at the upstream end. 2005 - Some new brush bundles in the brush boxes; some with missing bundles. Some boxes too low relative to high tide. 2010 - Site extended upstream. 2011 - Minor new erosion. 2013: No observed changes. [2013 Site ID: GEO_5-3_L]

USACE 2013 Photo #1

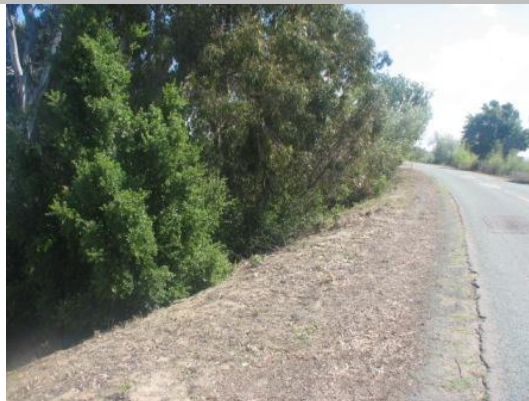
Photo 1 of 2 : richard_s_20140318_810.jpg

LM Start	6.90	Rating **	U	Issue No.	27
LM End	6.94	Issue Type +	Ma	Location *	LS
Category	Earthen Levee			GPS Latitude/Longitude	
				Start	End
Item	Trim / Thin Trees			38.175190 °	38.174610 °
				-121.580035 °	-121.579948 °
DWR ID	DWR_RD0563_01_s _ 2012_27				
Action/Comments					
Trim trees to at least five feet above ground level.

Side view of dense trees along landside slope and shoulder.

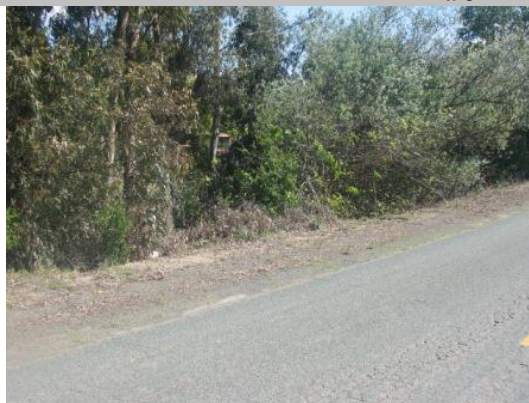
Photo 2 of 2 : richard_s_20140318_811.jpg

LM Start	6.90	Rating **	U	Issue No.	27 (cont)
LM End	6.94	Issue Type +	Ma	Location *	LS

Front view of dense trees along landside shoulder and slope.

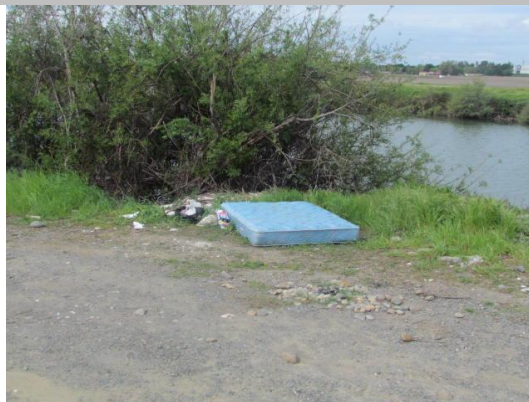
Photo 1 of 1 : richard_s_20140328_478.jpg

LM Start	7.52	Rating **	M	Issue No.	146
LM End	7.52	Issue Type +	En	Location *	WS
Category	Earthen Levee			GPS Latitude/Longitude	
				Start	End
Item	Encroachments				°
					°
DWR ID	DWR_RD0563_01_s_2014_146				
Action/Comments					
Garbage

Looking west at garbage on waterward slope and toe.

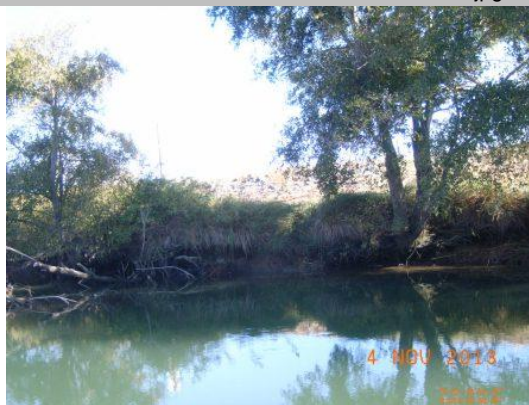
Photo 1 of 1 : USACE2013A_GEO_4-5_L_11.jpg

LM Start	7.64	Rating **	U	Issue No.	43
LM End	7.97	Issue Type +	Ma	Location *	WS
Category	Supplemental			GPS Latitude/Longitude	
				Start	End
Item	USACE Erosion Survey			38.164462 °	38.160888 °
				-121.583092 °	-121.584807 °
DWR ID					
Action/Comments					
Inspector Comments: 1997 - Pocket erosion at upstream end and into the levee toe under the Alder trees. 2003 - New brush boxes with wattles on bank. 2004 - No brush boxes. 2005 - Site extended from the downstream side of the bridge. Whole bank is vertical. 2010 - Some minor new erosion. 2011 - Site upgraded to CRITICAL. New erosion pockets throughout the site. Sites 4.5, and 4.6 were combined. 2013: No observed changes. [2013 Site ID: GEO_4-5_L]

USACE 2013 Photo #1

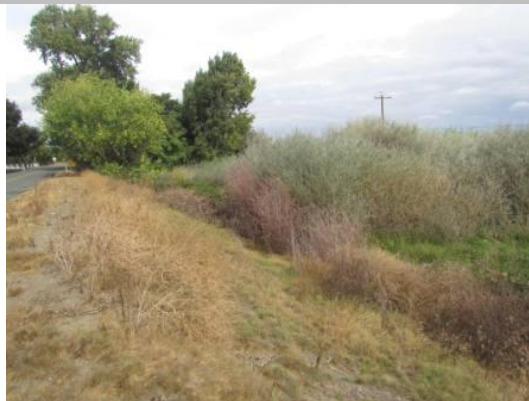
Photo 1 of 4 : richard_s_20140318_927.jpg

LM Start	7.97	Rating **	M	Issue No.	90
LM End	8.10	Issue Type +	Ma	Location *	LS
Category	Earthen Levee			GPS Latitude/Longitude	
				Start	End
Item	Vegetation			38.160800 °	38.160487 °
				-121.584598 °	-121.584717 °
DWR ID	DWR_RD0563_01_s _ 2012_90				
Action/Comments					
Remove the wild growth other than native grasses from the levee slopes.					
Inspector Comments: Berryvines and willows on landside toe.

Looking northeast at dense vegetation on landside toe.

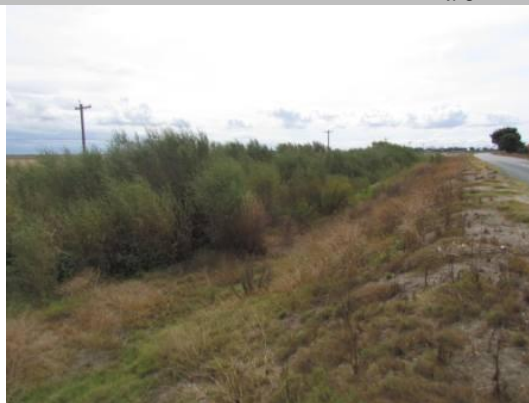
Photo 2 of 4 : richard_s_20140318_928.jpg

Looking southwest at dense vegetation on landside toe.

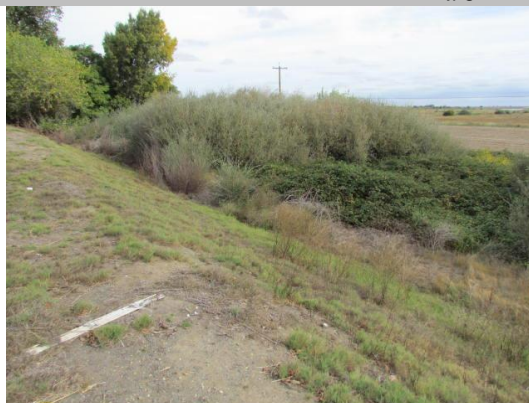
Photo 3 of 4 : richard_s_20140318_929.jpg

Looking northeast at dense vegetation on landside toe. (2012 Fall Inspection)

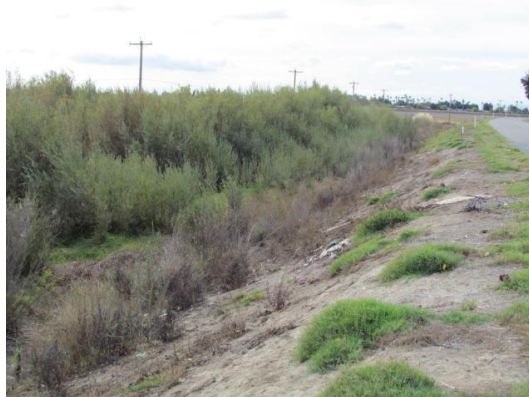
Photo 4 of 4 : richard_s_20140318_930.jpg

LM Start	7.97	Rating **	M	Issue No.	90 (cont)	
LM End	8.10	Issue Type +	Ma	Location *	LS	
Category	Earthen Levee			GPS Latitude/Longitude		
				Start		End
Item	Vegetation			38.160800 °	38.160487 °	
				-121.584598 °	-121.584717 °	
DWR ID	DWR_RD0563_01_s _ 2012_90					
Action/Comments						
Remove the wild growth other than native grasses from the levee

Looking south at dense vegetation on landside toe. (2012 Fall)

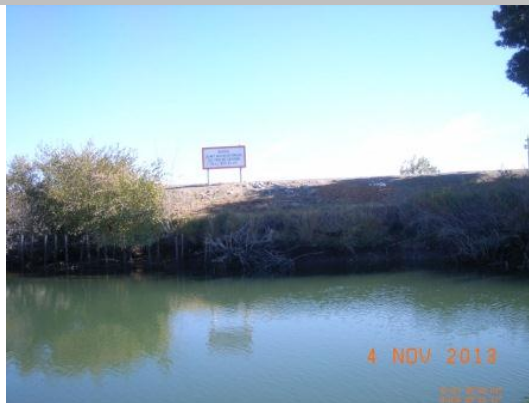
Photo 1 of 1 : USACE2013A_GEO_4-3_L_10.jpg

LM Start	8.05	Rating **	M	Issue No.	42
LM End	8.19	Issue Type +	Ma	Location *	WS
Category	Supplemental			GPS Latitude/Longitude	
				Start	End
Item	USACE Erosion Survey			38.160261 °	38.157625 °
				-121.585056 °	-121.586543 °
DWR ID					
Action/Comments					
Inspector Comments: 1997 - Pockets of erosion into the levee toe. 1999 - Minor rock riprap and willow bundles place in a couple of spots. 2001 - Staked, low fascine walls at bankline. 2003 - Small unprotected pockets still eroding. 2004 - Numerous brush boxes, some falling apart, some with new bundles. 2005 - Some new brush boxes installed; some boxes are empty. Levee slope and banks still look bad with pocket scallops into the levee slopes. 2011 - Erosion continues and the number of pockets is increasing. 2013: Some of the downstream end was repaired by the RD. [2013 Site ID: GEO_4-3_L]

USACE 2013 Photo #1

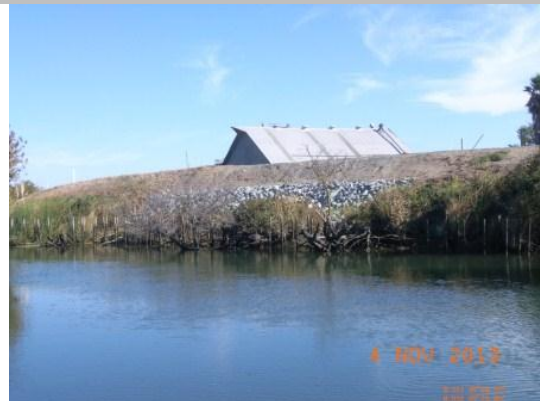
Photo 1 of 1 : USACE2013A_GEO_3-8_L_16.jpg

LM Start	8.28	Rating **	M	Issue No.	41
LM End	8.76	Issue Type +	Ma	Location *	WS
Category	Supplemental			GPS Latitude/Longitude	
				Start	End
Item	USACE Erosion Survey			38.156987 °	38.152919 °
				-121.587427 °	-121.591129 °
DWR ID					
Action/Comments					
Inspector Comments: 1997 - Pockets of erosion into the levee at the water line. Alders are being undercut and rotating out into the channel. Damaged rock at upstream end. 2000 - New minor erosion. 2001 - Staked low fascine walls at bankline. 2002 - New "Brush Boxes" along the bank toe. 2003 - New erosion pockets in the middle of the site. 2005 - Some new bundles in the brush boxes. 2011 - Site upgraded to CRITICAL. Significant new erosion. Sites 3.6, 3.7, 3.71, and 4.0 were combined. 2012 - Rock has been placed in some of the erosion pockets since last year, however site remains critical. 2013: Site no longer critical. The worst pockets were filled with rock by the local RD. [2013 Site ID: GEO_3-8_L]

USACE 2013 Photo #1

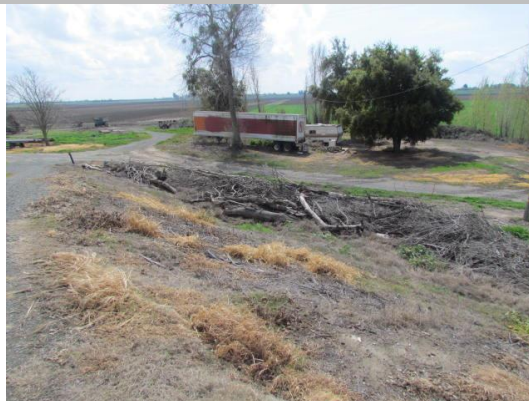
Photo 1 of 2 : richard_s_20140318_902.jpg

LM Start	9.50	Rating **	U	Issue No.	73
LM End	9.50	Issue Type +	Ma	Location *	LS
Category	Earthen Levee			GPS Latitude/Longitude	
				Start	End
Item	Encroachments			38.145957 °	38.145957 °
				-121.589653 °	-121.589653 °
DWR ID	DWR_RD0563_01_s _ 2012_73				
Action/Comments					
Prunings					
Inspector Comments: Large pruning pile on landward toe.

Looking east at prunings on landside slope and toe.

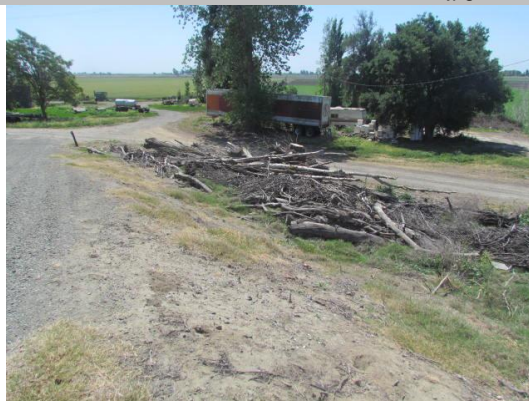
Photo 2 of 2 : richard_s_20140318_903.jpg

LM Start	9.50	Rating **	U	Issue No.	73 (cont)
LM End	9.50	Issue Type +	Ma	Location *	LS

Looking east at prunings on landward slope. (Spring 2013)

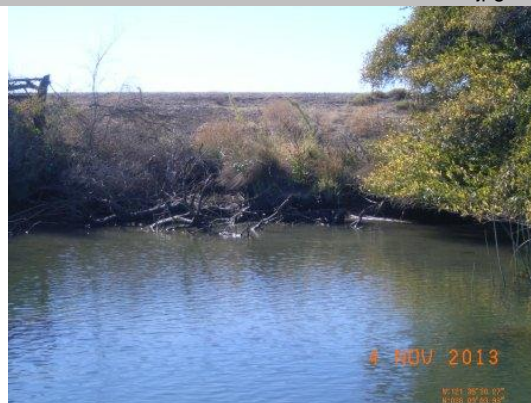
Photo 1 of 1 : USACE2013A_GEO_2-5_L_10.jpg

LM Start	9.74	Rating **	M	Issue No.	40
LM End	9.92	Issue Type +	Ma	Location *	WS
Category	Supplemental			GPS Latitude/Longitude	
				Start	End
Item	USACE Erosion Survey			38.150820 °	38.150647 °
				-121.593650 °	-121.596858 °
DWR ID					
Action/Comments					
Inspector Comments: 1997 - Erosion pockets into the toe of the levee. 2001 - Staked low fascine walls at the bankline. 2004 - Numerous "Brush Boxes." 2005 - Some new bundles in the brush boxes. 2012 - Site extended downstream to account for new bank sloughing. 2013: Some rock added to the upstream end by the local RD. [2013 Site ID: GEO 2-5 L]

USACE 2013 Photo #1

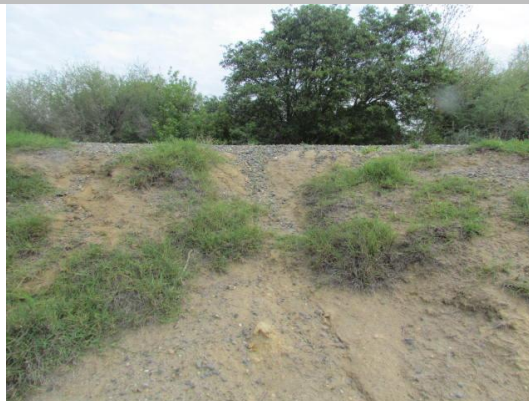
Photo 2 of 2 : richard_s_20140328_480.jpg

LM Start	9.83	Rating **	M	Issue No.	99 (cont)	
LM End	9.83	Issue Type +	Ma	Location *	LS	
Category	Earthen Levee			GPS Latitude/Longitude		
				Start	End	
Item	Erosion / Bank Caving			38.149905 °	38.149905 °	
				-121.592910 °	-121.592910 °	
DWR ID	DWR_RD0563_01_s _ 2013_99					
Action/Comments						
Note and monitor erosion site.

Looking west at minor erosion on landward shoulder and slope.

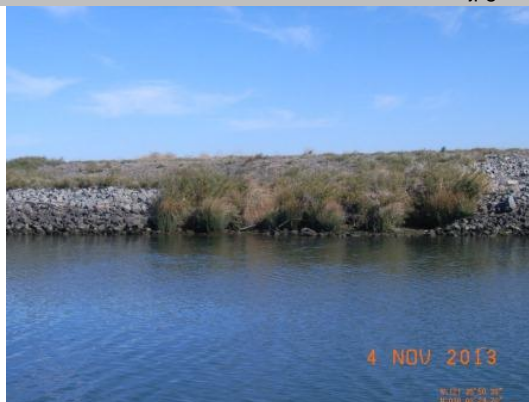
Photo 1 of 1 : USACE2013A_GEO_1-7_L_3.jpg

LM Start	10.46	Rating **	M	Issue No.	39
LM End	10.76	Issue Type +	Ma	Location *	WS
Category	Supplemental			GPS Latitude/Longitude	
				Start	End
Item	USACE Erosion Survey			38.143519 °	38.139918 °
				-121.599677 °	-121.596986 °
DWR ID					
Action/Comments					
Inspector Comments: 1997 - Old damaged rock riprap along the toe. 1999 - Downstream end (400 ft) repaired with rock. 2002 - New rock/concrete rubble section on the downstream end. 2004 - Small pocket repairs at the downstream end. 2005 - Some new bundles in the brush boxes. 2012 - Some rock has been placed in last year. 2013: No observed changes. [2013 Site ID: GEO_1-7_L]

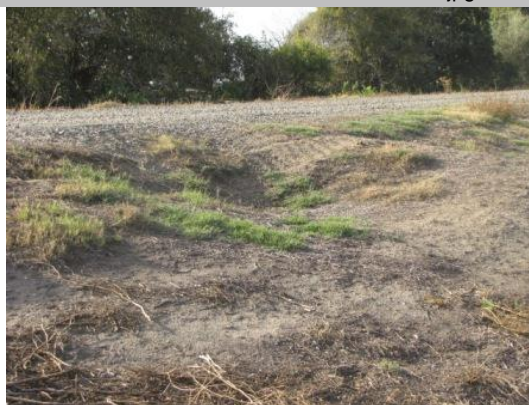
Photo 2 of 4 : richard_s_20140318_907.jpg

LM Start	10.77	Rating **	U	Issue No.	76
LM End	10.77	Issue Type +	Ma	Location *	LS
Category	Earthen Levee			GPS Latitude/Longitude	
				Start	End
Item	Slope Stability			38.141940 °	38.141940 °
				-121.598033 °	-121.598033 °
DWR ID	DWR_RD0563_01_s _ 2012_76				
Action/Comments					
Repair slope instability. Inspector Comments: Deep depression on landside shoulder and slope; possible pipe collapse.

Looking west at depression on landside shoulder and slope.

LM Start	10.77	Rating **	U	Issue No.	76 (cont)
LM End	10.77	Issue Type +	Ma	Location *	LS
Category	Earthen Levee			GPS Latitude/Longitude	
				Start	End
Item	Slope Stability			38.141940 °	38.141940 °
				-121.598033 °	-121.598033 °
DWR ID	DWR_RD0563_01_s _ 2012_76				
Action/Comments					
Repair slope instability.

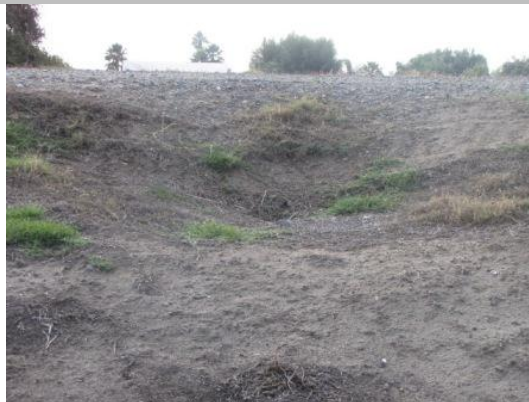
Photo 3 of 4 : richard_s_20140318_908.jpg

Looking west at depression on landside shoulder and slope from landside toe.

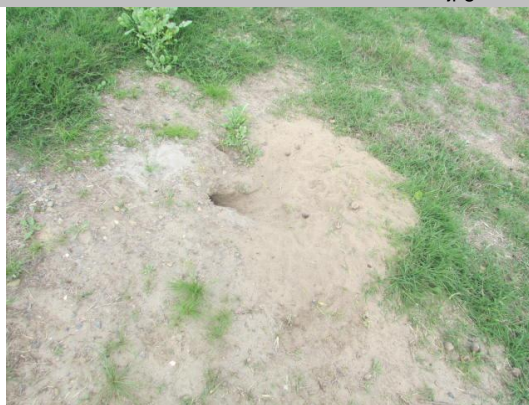
Photo 1 of 1 : richard_s_20140328_483.jpg

LM Start	10.82	Rating **	M	Issue No.	77
LM End	10.82	Issue Type +	Ma	Location *	LS
Category	Earthen Levee			GPS Latitude/Longitude	
				Start	End
Item	Animal Control			38.141362 °	38.141362 °
				-121.597598 °	-121.597598 °
DWR ID	DWR_RD0563_01_s _ 2012_77				
Action/Comments					
No rodents visible, but rodent burrows visible; need to backfill and compact or grout burrows.

Looking at typical rodent holes on landward slope.

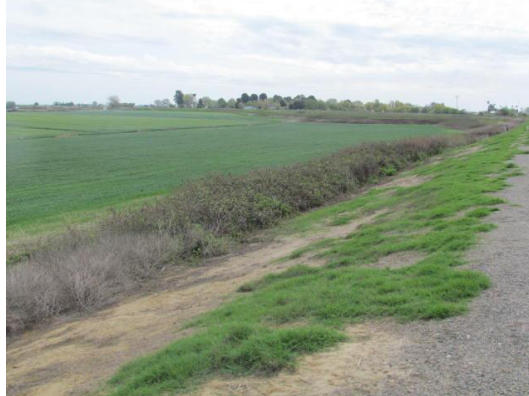
Photo 1 of 2 : richard_s_20140328_484.jpg

LM Start	11.49	Rating **	U	Issue No.	100
LM End	12.04	Issue Type +	Ma	Location *	LS
Category	Earthen Levee			GPS Latitude/Longitude	
				Start	End
Item	Vegetation			38.134880 °	38.130448 °
				-121.592180 °	-121.587087 °
DWR ID	DWR_RD0563_01_s _ 2013_100				
Action/Comments					
Remove the wild growth other than native grasses from the levee slopes. Inspector Comments: Wild rose or grape vines on landward slope and toe.

Looking south at dense vegetation at landward toe.

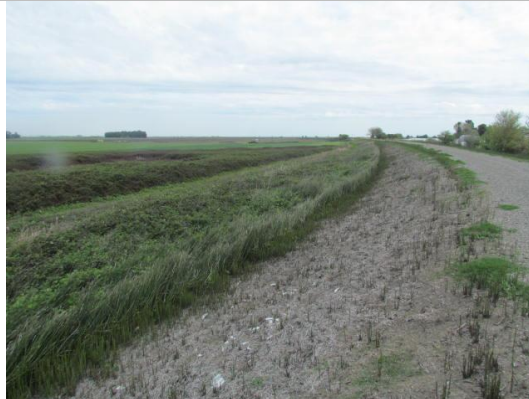
Photo 2 of 2 : richard_s_20140328_485.jpg

Looking south at additional dense vegetation at landward toe.

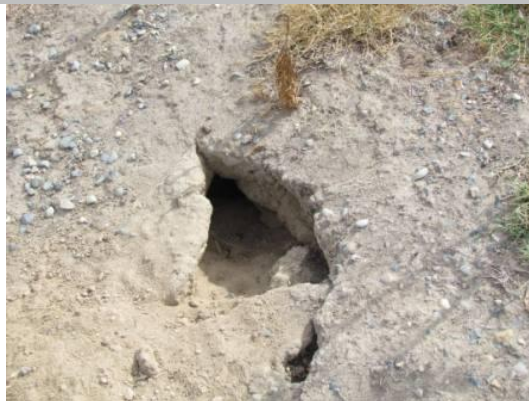
Photo 1 of 3 : richard_s_20140318_931.jpg

LM Start	11.63	Rating **	M	Issue No.	91
LM End	11.63	Issue Type +	Ma	Location *	LS
Category	Earthen Levee			GPS Latitude/Longitude	
				Start	End
Item	Animal Control			38.131943 °	38.131943 °
				-121.588912 °	-121.588912 °
DWR ID	DWR_RD0563_01_s _ 2012_91				
Action/Comments					
No rodents visible, but rodent burrows visible; need to backfill and

Looking east at rodent hole on landside slope.

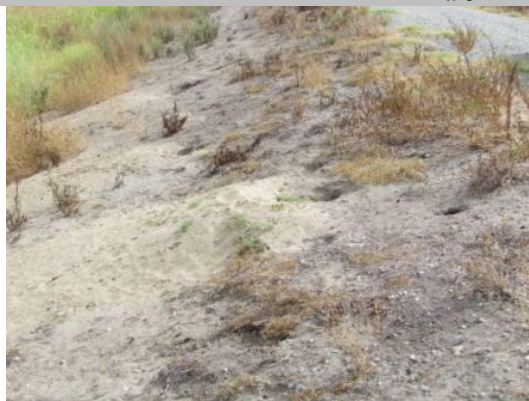
Photo 2 of 3 : richard_s_20140318_932.jpg

Looking south at rodent holes on landside slope.

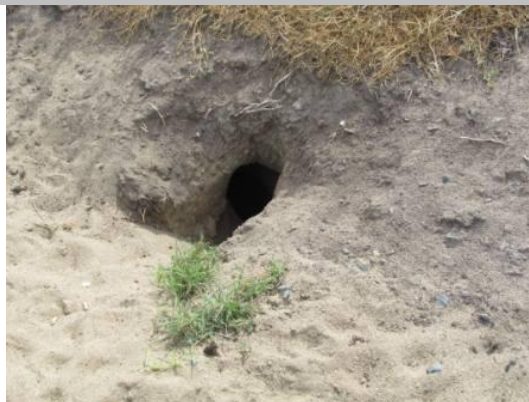
Photo 3 of 3 : richard_s_20140318_933.jpg

Looking west at rodent hole on landside slope.

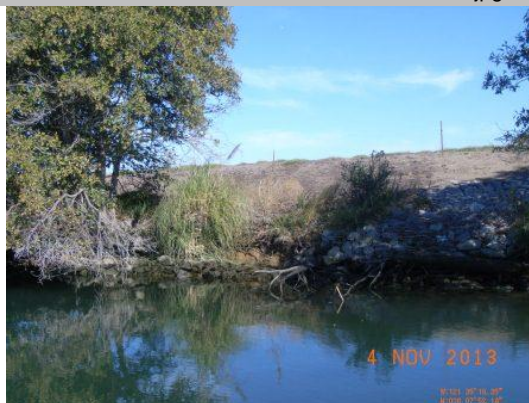
Photo 1 of 1 : USACE2013A_GEO_0-3_L_16.jpg

LM Start	11.69	Rating **	M	Issue No.	38
LM End	11.79	Issue Type +	Ma	Location *	WS
Category	Supplemental			GPS Latitude/Longitude	
				Start	End
Item	USACE Erosion Survey			38.131126 °	38.129948 °
				-121.588337 °	-121.585026 °
DWR ID					
Action/Comments					
Inspector Comments: 1997 - Erosion pockets into the levee toe. 1999 -

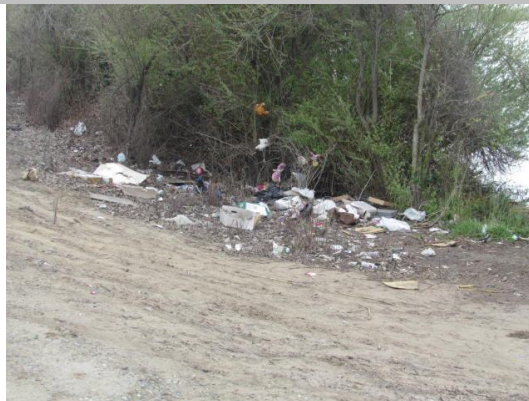
Photo 1 of 1 : richard_s_20140328_486.jpg

LM Start	12.21	Rating **	M	Issue No.	107
LM End	12.21	Issue Type +	Ma	Location *	WS
Category	Earthen Levee			GPS Latitude/Longitude	
				Start	End
Item	Encroachments			38.130776 °	38.130776 °
				-121.579063 °	-121.579063 °
DWR ID	DWR_RD0563_01_f_2013_107				
Action/Comments					
Garbage

Looking southwest at garbage at waterward slope and toe.
